BMW 3 G20
Saloon/sedan
from 11/2018

| ID no. | Version no. | Version date | Page |
| WBA-G20 | 1 | 11/2018 | 1 |

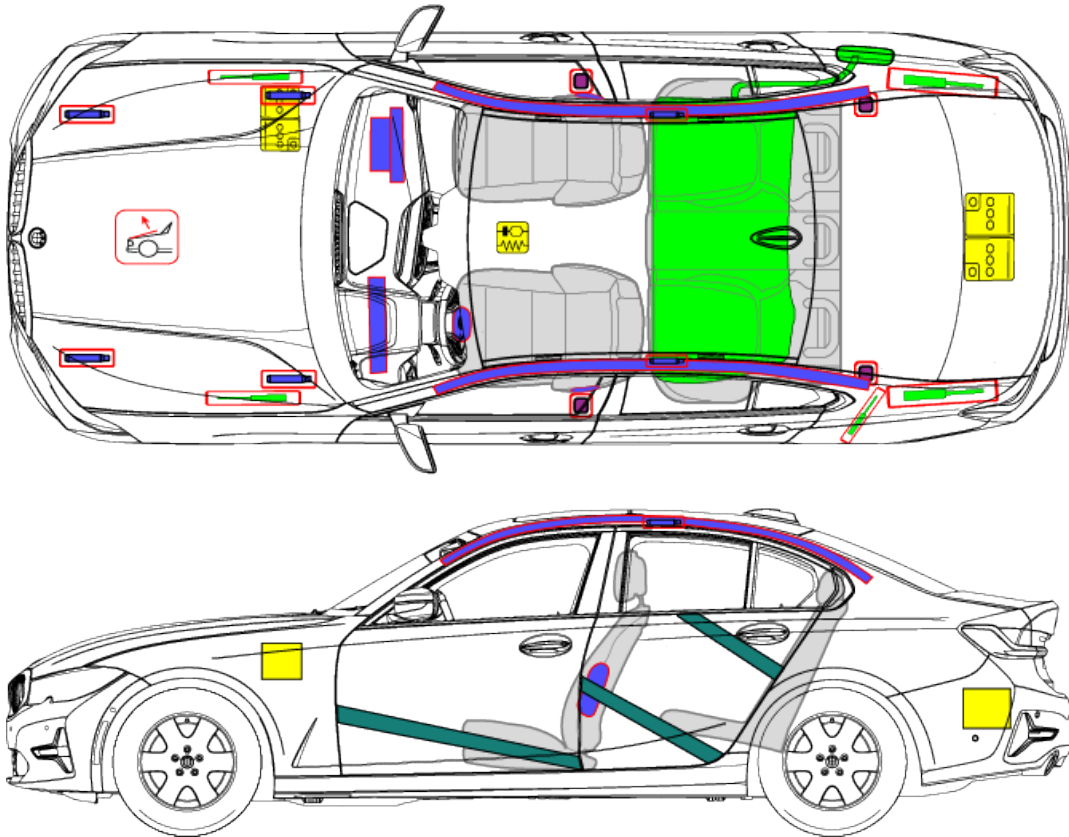
This overview shows the maximum range of equipment of the vehicle.
